NRCS Repairs Gully known as the “Grand Canyon of Morgantown”

June 29, 2012

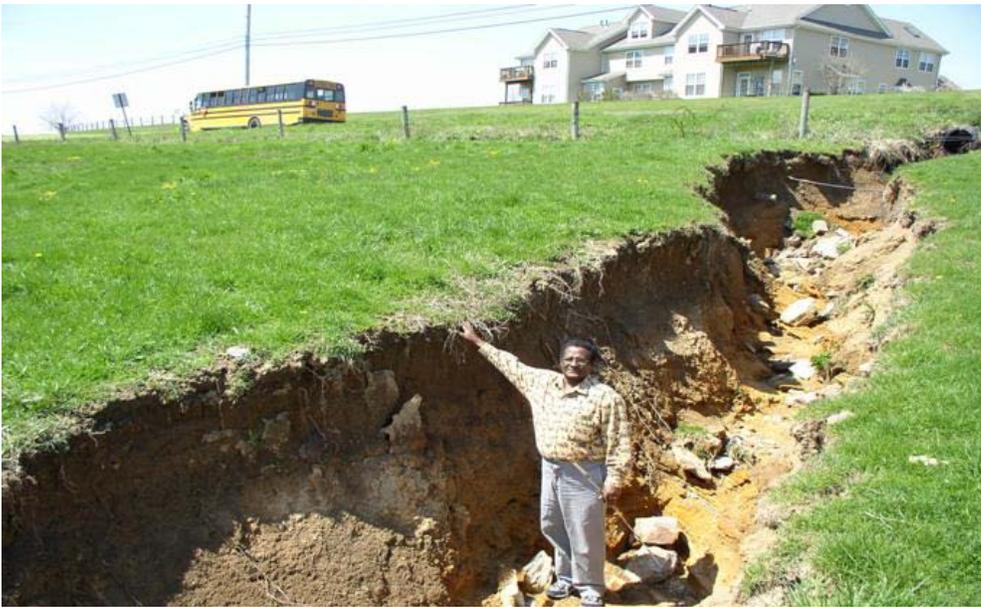
According to Mr. Beiler, the gully didn't begin to form until a new gas station and car dealership were constructed in 2000. Since then, water runoff from parking lots has been a continuous issue for the Beiler farm. Water is directed onto the farm via a 12-inch pipe that passes under Twin Valley Road and drains directly into his hayfield. As a result, continuous erosion caused the deep gully to form in less than nine years. The Beiler Gully ranged from five to seven feet in depth, from nine to eleven feet in width, and was 280 feet long.

Before: NRCS employee demonstrates the massive size of the gully that formed on Kevin Beiler's farm.

Mr. Beiler contacted the NRCS Leesport field office for assistance. NRCS staff worked closely with Caernarvon Township officials to use Best Management Practices (BMPs) to repair the gully since it was determined that it would eventually lead to the degradation of Twin Valley Road.

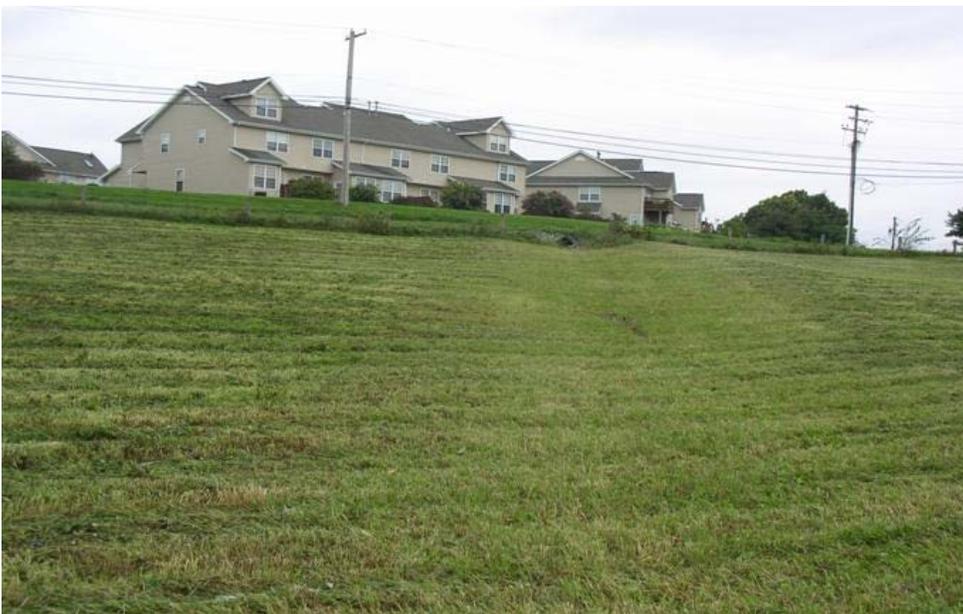
After: With NRCS assistance, the gully has been returned to an established and erosion-free hay field.

The voluntary, incentives-based conservation approach is working; the farmer has made progress in reducing sediment and nutrient losses from farm fields through conservation practice installed through the CBWI program. At this time, the gully has been returned to an established and erosion free hay field.
